## Study on Asphalt Pavement Distress: A Case Study in Turkish Republic of Northern Cyprus

**ABSTRACT.** *In past few years, Pavement Engineers are exploring new techniques and methods to reduce the cost of pavement construction, while increasing its service life. So it manages the ingredient of pavement material due to the pavement failure, although to characterize the thickness of pavement layers. The road must be designed and properly constructed in the site and then proper maintenance necessary. Meanwhile, the road must not be designed in a short period because of deterioration will start and shows the distress on the pavement surface like surface deformation, surface defect bleeding, disintegration pothole, and cracking. The causes of deterioration are environmental factors (moisture, climate), improper maintenance, Poor material, improper pavement design, traffic over load, traffic volume and subgrade failure. This research paper evaluates the current condition of asphalt pavement distresses which are existed in North Cyprus. A condition survey conducted from Lefkosa to Famagusta and the length of the highway is 57.9 km. It has achieved and proved 10 types of pavement distre

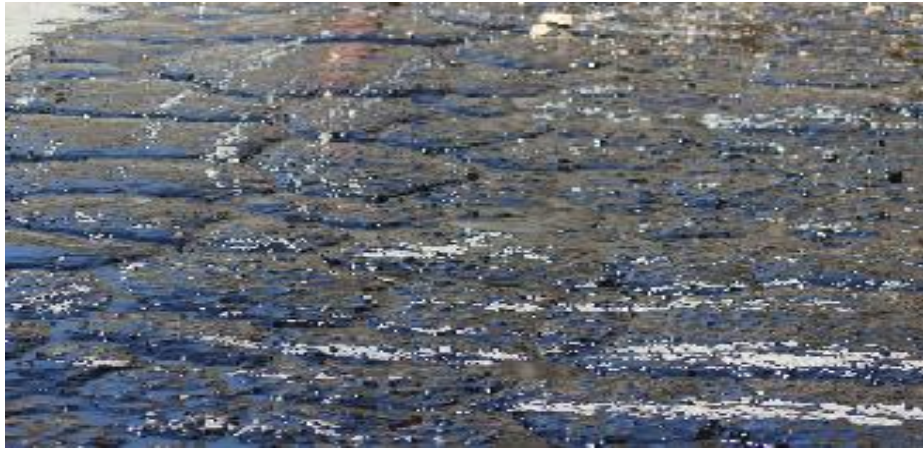
**Fig. 1:** Crocodile Cracks in flexible Pavement

This crack is also defined as a fatigue crack. At first, when it appears on the pavement surface, it looks like longitudinal cracks in the wheel paths but after growing and advancing, it interconnects and looks like an alligator crack though finally, it shows potholes [19]. As shown in Figure 1. There are many factors causing this crack like heavy traffic, base course, insufficient surface, subgrade strength, thin surface, poor drainage which causes penetration to the subgrade and base course and destroy the pavement [20].

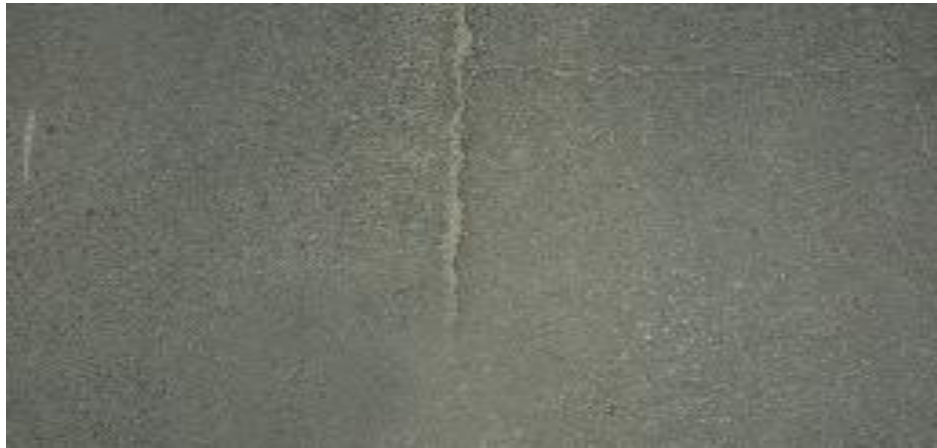
**Fig. 2:** Longitudinal crack in flexible Pavement

There are some fractions that are mostly appearing in the centerlines of the pavements which is called longitudinal cracks [21]. As shown in Figure 2. Climate affects the shrinkage of the asphalt layer and it helps these cracks to grow. The same time joining two sections of the pavement with a poor construction is another cause and temperature cycling or unfair operations on the paver could be the reasons for these cracks [22].

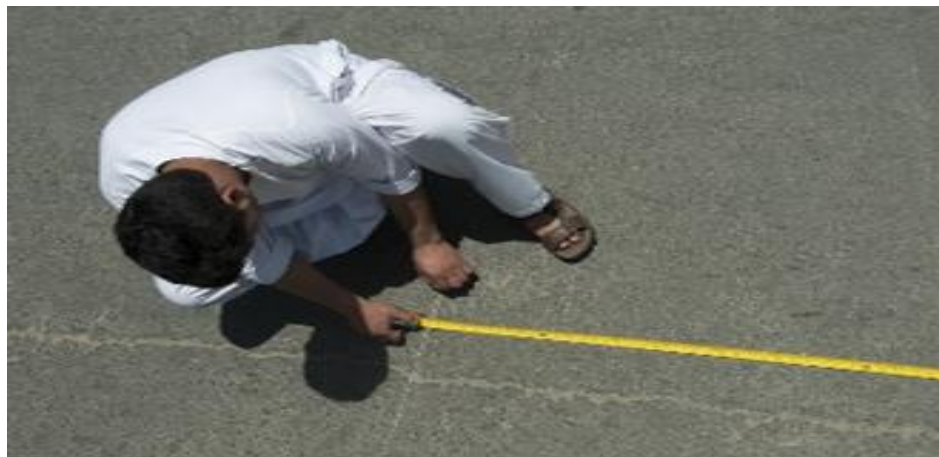
**Fig. 3:** Transverse crack in flexible Pavement [24].

These cracks are mostly happening in a perpendicular direction to the centerlines and would not locate on Portland where cement and concrete joins as shown in Figure 3. It also can appear on the surface [23]. Some causes of these cracks are: wrong set up of the asphalt mixtures, low temperature and sub-base of pavement layers [23].

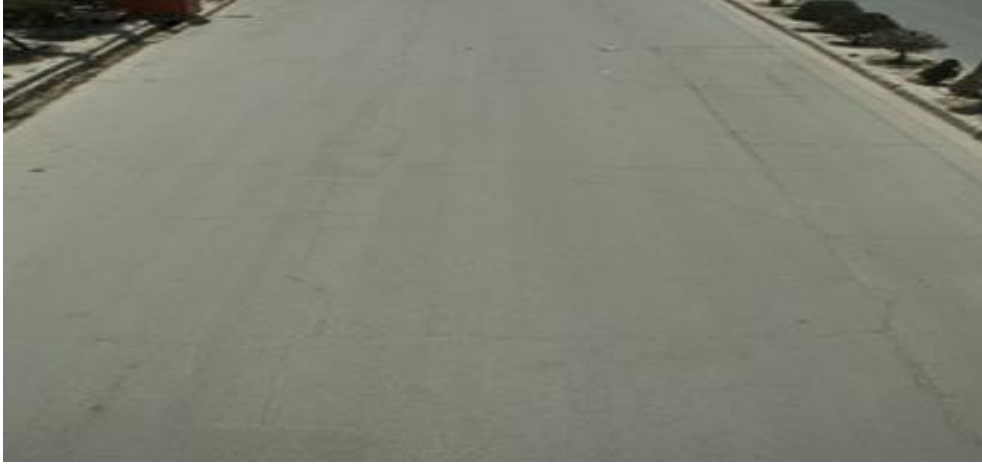
**Fig. 4:** Block crack in flexible Pavement

Block cracking happens unlike other cracks specifically alligator cracks, they are a collection of interconnected rectangular pieces which could be all throughout the width of the pavement not just in the wheels' paths as demonstrated in Figure 4. If the severity is low in these cracks, it is possible to repair and fix it with a "thin wearing course". But high severity may need overlay and recycling. The causes are proved to be aging, oxidative hardening of the Asphalt Concrete (AC), wrong binder mixture, high void content, shrinkage and temperature cycling [25].

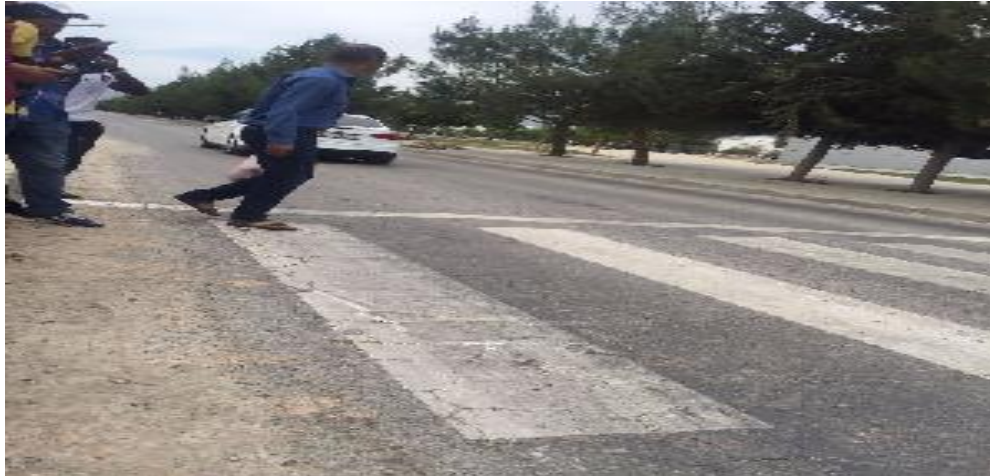
**Fig. 5:** Edge crack in flexible Pavement

Distress in narrow pavements are edge cracks which start from the edge and extends, it looks similar to fatigue cracks. They happen because of weak material or excess moisture which is not supporting the shoulder of the pavement well as demonstrated in Figure 5. Causes are different according to the pavement situation. For instance, it could be from poor drainage which the water is near to the edge, soil movement beneath the pavement, heavy traffic close to edge, infiltration of water to the base, lack of strength in surface and base [26].

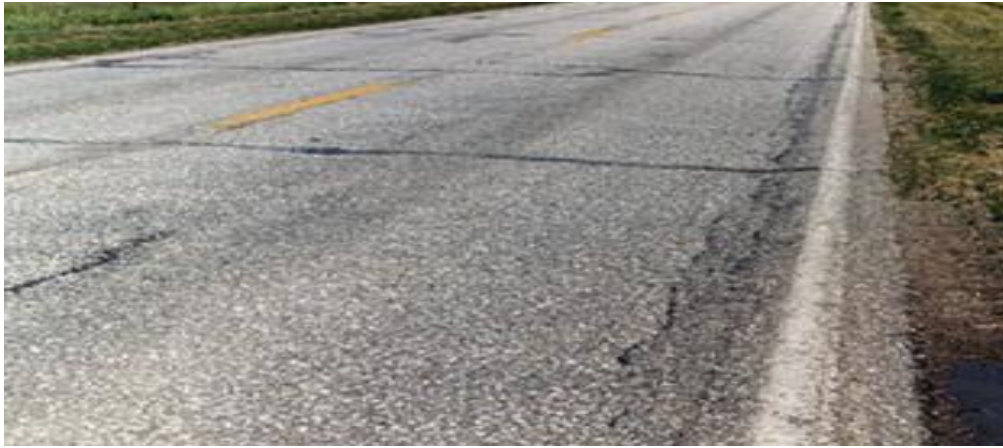
**Fig.6:** Rutting crack in flexible Pavement

Depression of the longitudinal surface in wheel path is rutting which deteriorate the asphalt and cause other cracks. It is actually a surface failure which holds water in the wheel path [27]. A wide narrow crack shows a subgrade failure as demonstrated in Figure 6. It is possible to say that causes are low air voids, too much dust, rounded aggregate, high asphalt content, and too much natural sand [28].

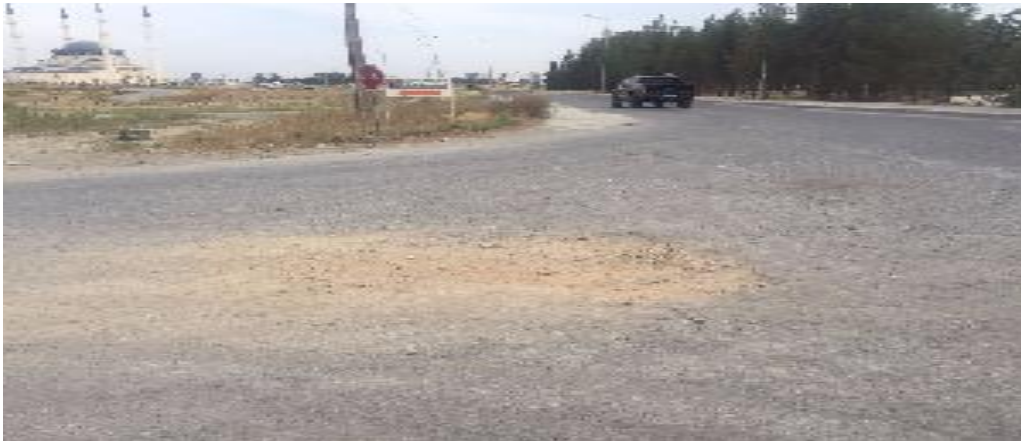
**Fig.7:** Pothole in flexible Pavement

There are holes like depressions in a bowl-shape, which is a progressive failure and called pothole. A tiny piece of the first layer is destroyed and gradually distress goes down to other layers in the bottom of the pavement as demonstrated in Figure 7. The causes are a lack of pavement thickness to handle traffic in freeze or thaw times. Meanwhile, Poor drainage as others, raveling of cracks which cause pothole. They can be repaired with rebuilding or excavating, the repaired area may require immense potholes [29].

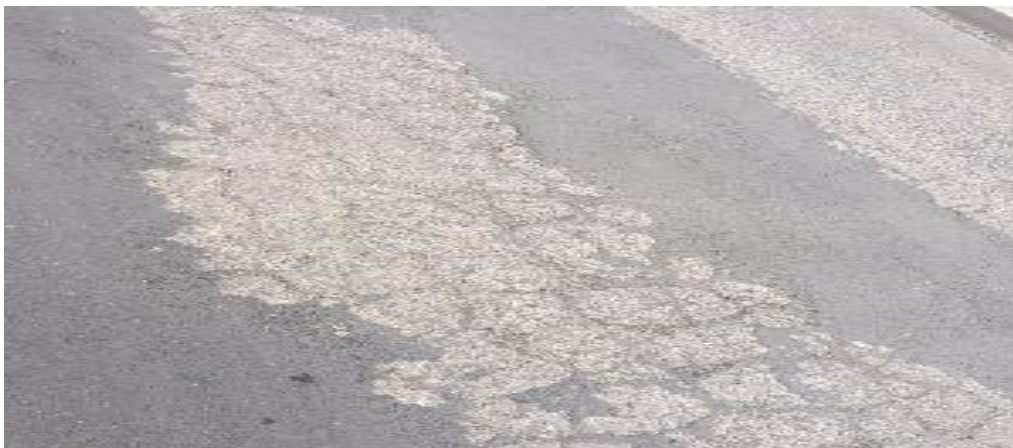
**Fig.8:** Flexible pavement Patching sample

There are small pieces of asphalt pavement in the surface which is more than 0.1 square meters and they are replaced or their materials increased in a portion in the construction of pavement called patch deterioration as demonstrated in Figure 8. Several issues cause patching for instance when the original distress spreads, poor connection would be between the patch and existing pavement, wrong compaction while patching, wrong material mixing, and rut settlement appealing at the perimeter or inside the interior side of the patch [29].

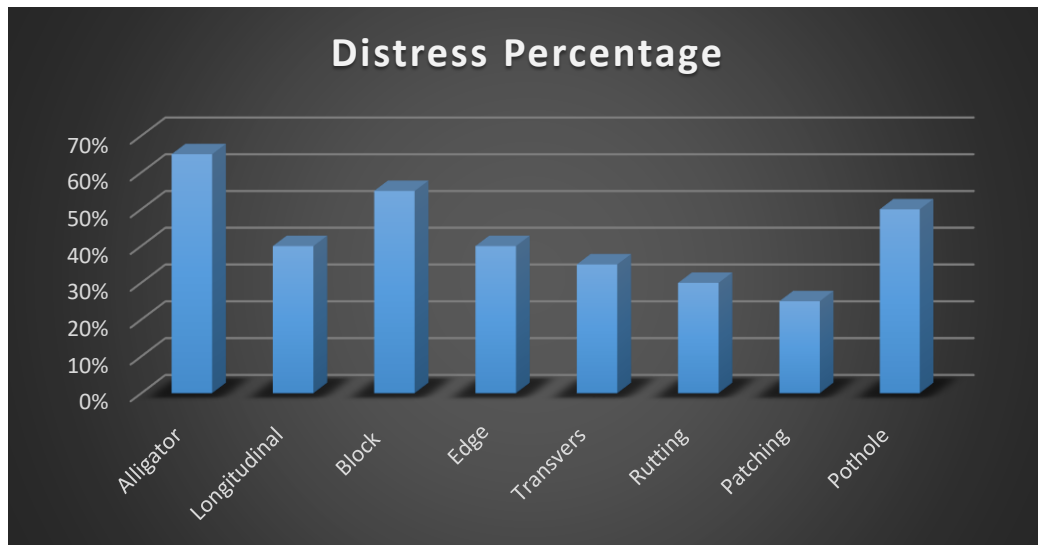
**Chart -1:** Magnitude of each section covered with distresses

The magnitude of each section covered with distresses were specified and compared with total area that was damaged. In Chart -1 as shown the percentage of distresses is calculated.

Result shows alligator crack severity in three sections of highway (H, H, M) covered the highway 60%, potholes severity in three section of highway (H, M, H) covered the highway 49%, block severity in three section of highway (H, M, H) covered the highway 56%, longitudinal crack severity in three section of highway (H, H, M) covered the highway 38%, transverse crack severity in three section of highway (H, M, I) covered the highway 35%, edge crack severity in three sections of highway (L, M, H) covered the highway 38%, rutting severity in three section of highway (M, L, L) covered the highway 30%, patching severity in three sections of highway (L, L, M) covered the highway 22%.

Based on the study findings, it is recommended to use crack filling and sealing, overlay, patching and shoulder improvement due to the others treatment alternative is not available there.
