## Seismic Performance Assessment of Deteriorating Reinforced Concrete Box Culvert

**ABSTRACT.** *A culvert is a crucial component of highways whose proper operation is connected indirectly to the state's economy and the effectiveness and safety of road transportation. Therefore, it is crucial to assess the culvert structure's safety. In this work, a seismic assessment of undamaged and damaged reinforced concrete box culverts is performed. The deterioration in culvert slab thickness over time due to corrosion is considered. The structure was subjected to seismic loading along with standard static loading to observe the performance of a box culvert. The results show that the seismic response of culverts would be influenced by aging and deterioration of slab thickness from its original conditions. The finding of this study highlights the importance of considering the effect of corrosion on the slab thickness when assessing the seismic performance of culverts, as it can have a significant impact on the structure's safety.*

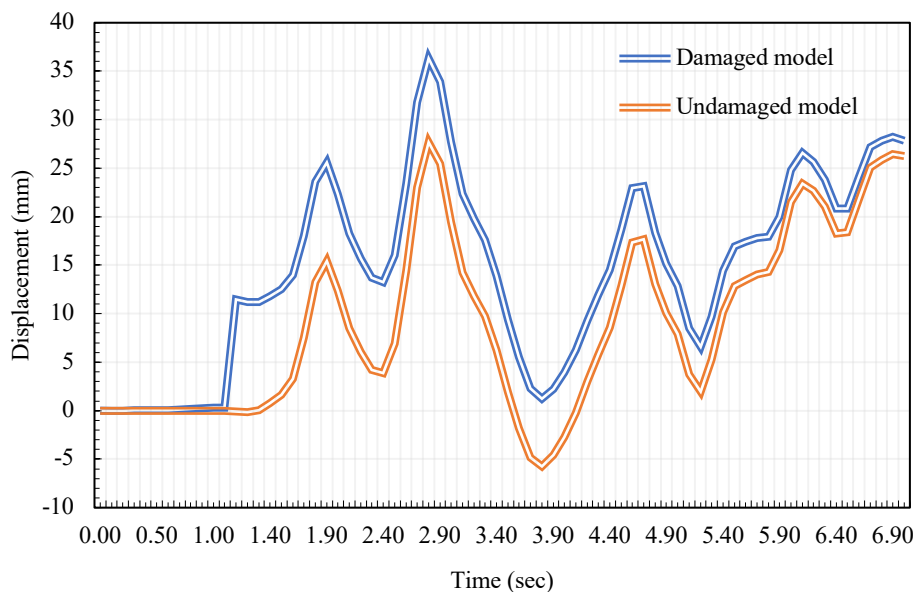
**Fig -5:** Displacement versus time response of undeteriorated and deteriorated models

Figure 5 showed the maximum deformation response of both models in the x-direction (U1), where it was observed that the maximum deformation occurred for the deteriorated culvert where the peak deformation was at a time instant of 2.9 seconds of the earthquake excitation. Overall, the deterioration of the slab thickness can significantly impact the structure's safety, and the seismic response of culverts would be influenced by the aging and deterioration of the slab thickness from its original conditions.
